Appraisal Report 22 - 5262

1924 Studebaker 4 door sedan

This report prepared for the Estate of Marl Brown

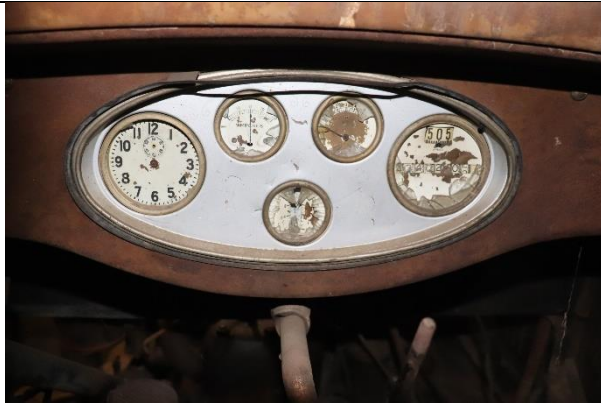
The odometer reading of 43,402 miles is probably the actual distance the chassis has seen but the gauges are damaged and difficult to read.

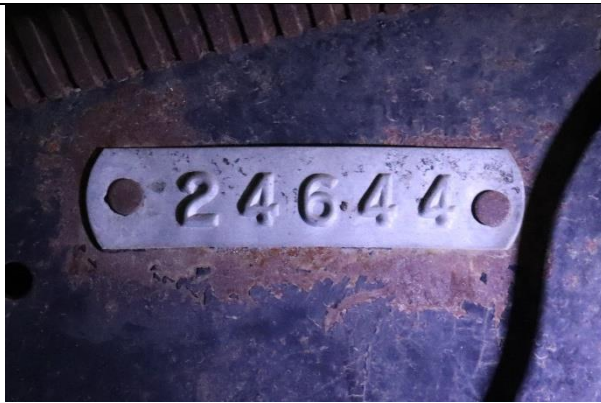
The VIN number **24644** may only be decoded as a sequential production number. It does not decode as a typical Studebaker VIN which normally has seven characters. This may not be an actual VIN. References suggest the VIN is stamped on the driver's side frame above the front axle, and if so was not found there. This tag is riveted to the firewall.

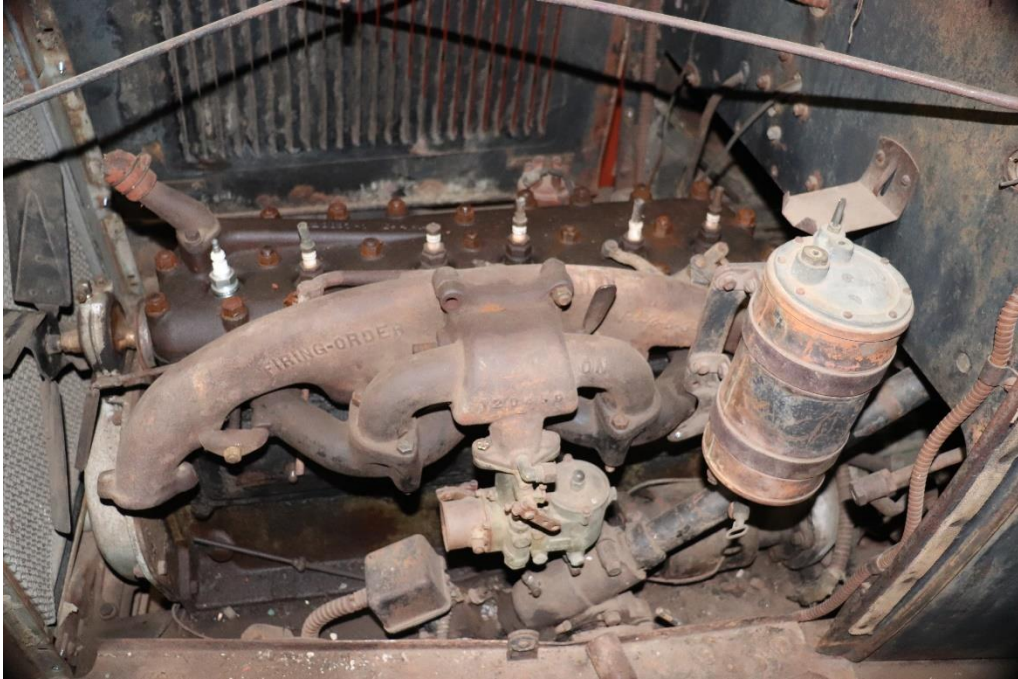
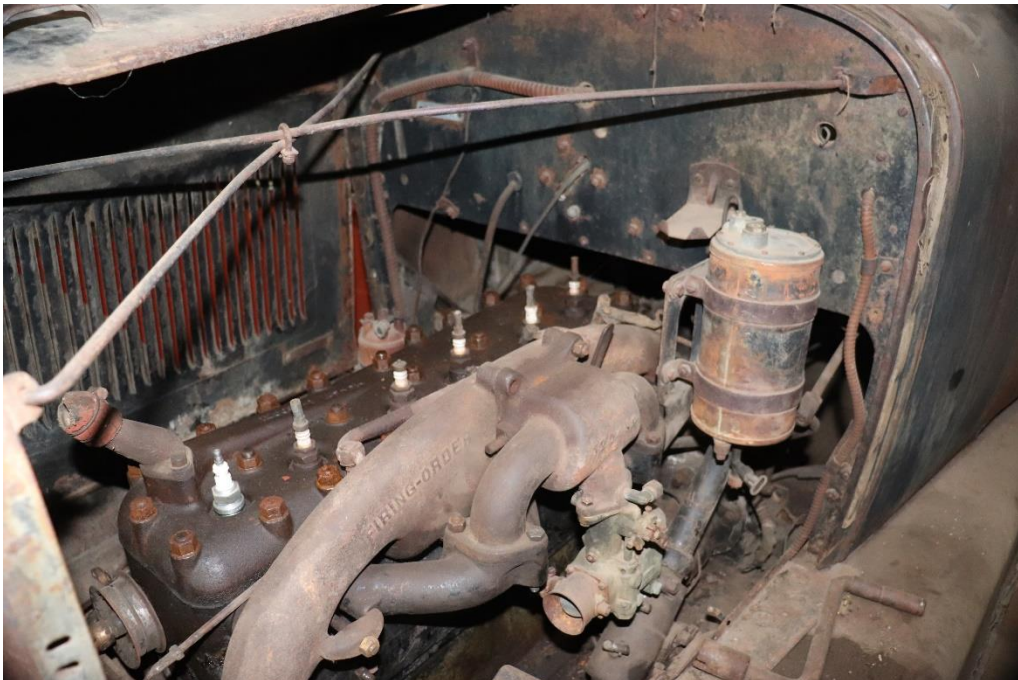
The engine is probably the original inline six cylinder. It is not operational with hoses and ignition wiring not attached but otherwise seems complete. Power is transferred to the rear wheels via a manual transmission.

The engine is probably the original flathead six cylinder. The engine size is not known as the model series could not be determined from the VIN. The engine is not operable.

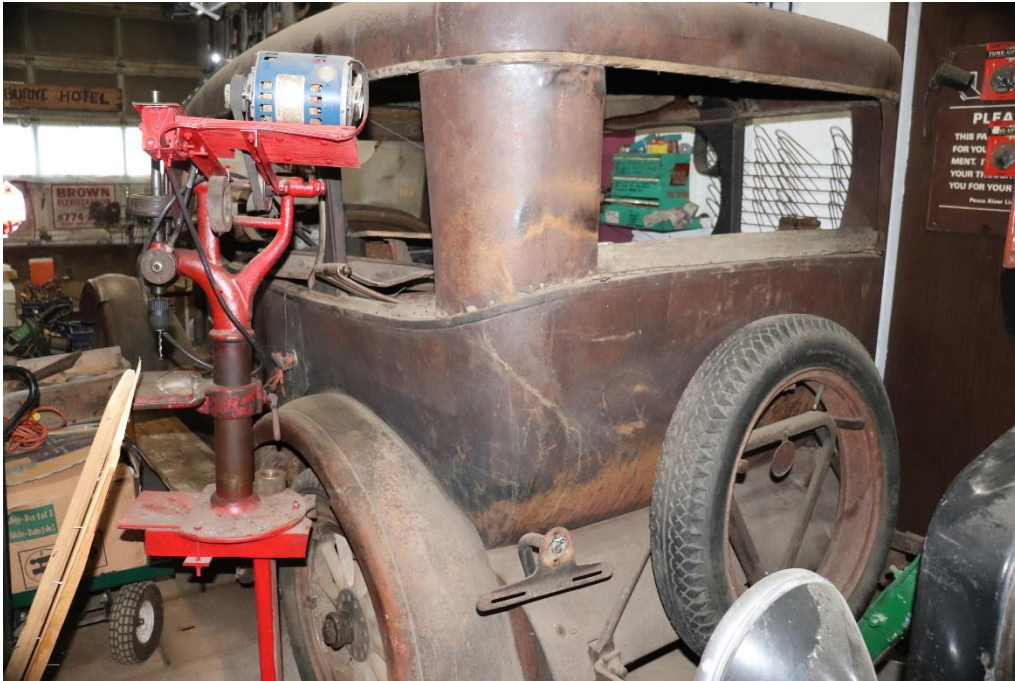
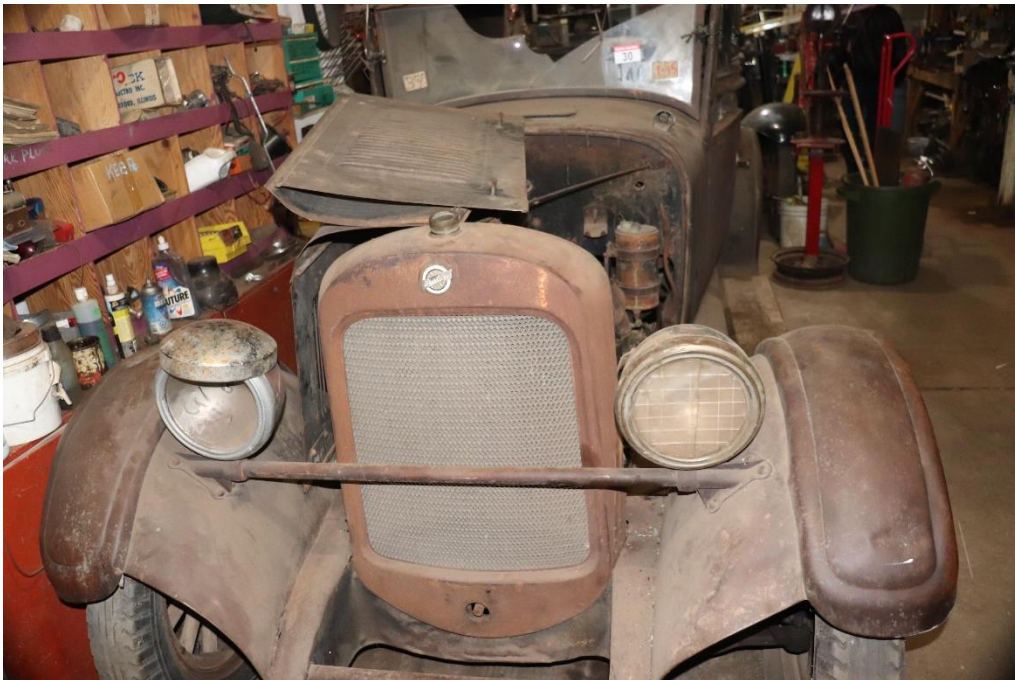
The front and rear bumpers have been removed and are in storage inside the car. All body panels are unrestored and ready for restoration.

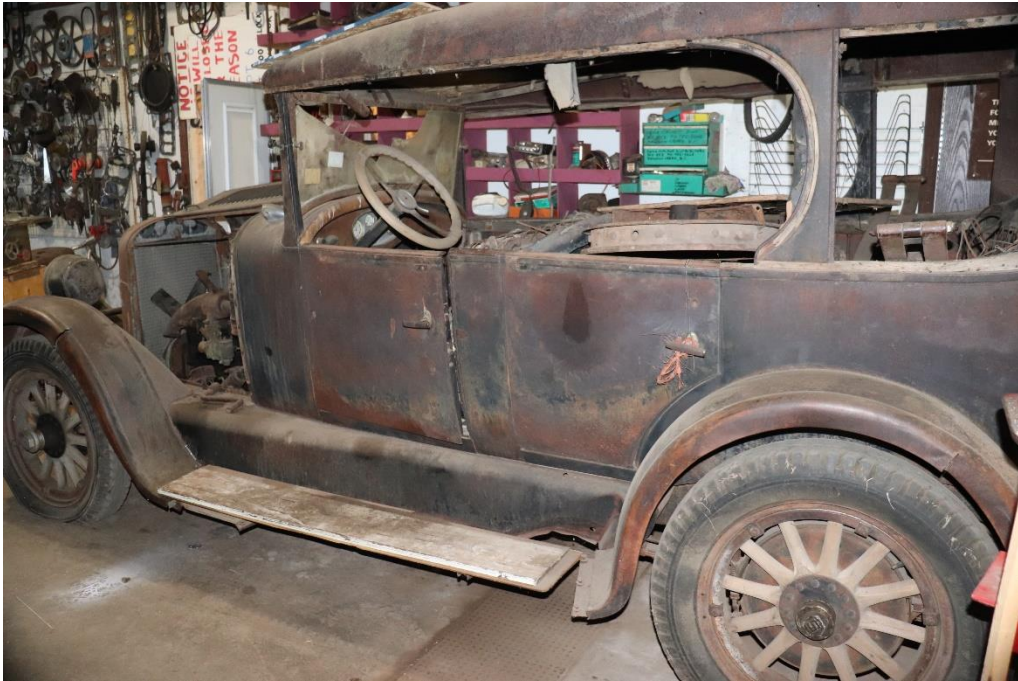
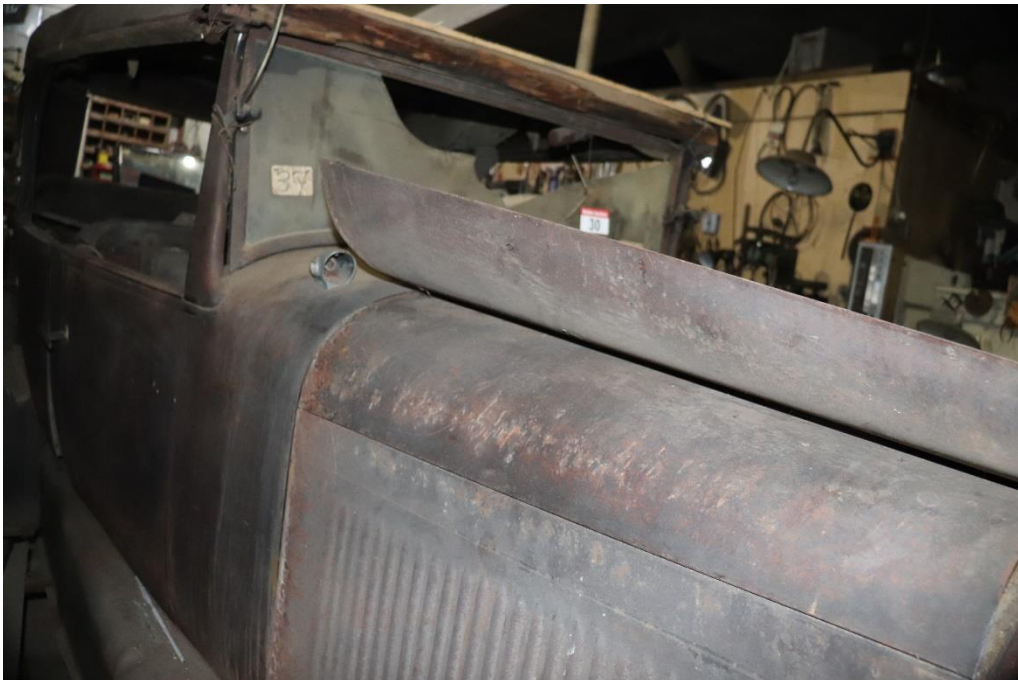
The side panels like the rest of the car are ready for restoration. The glass has been removed or like the windshield, is badly damaged.

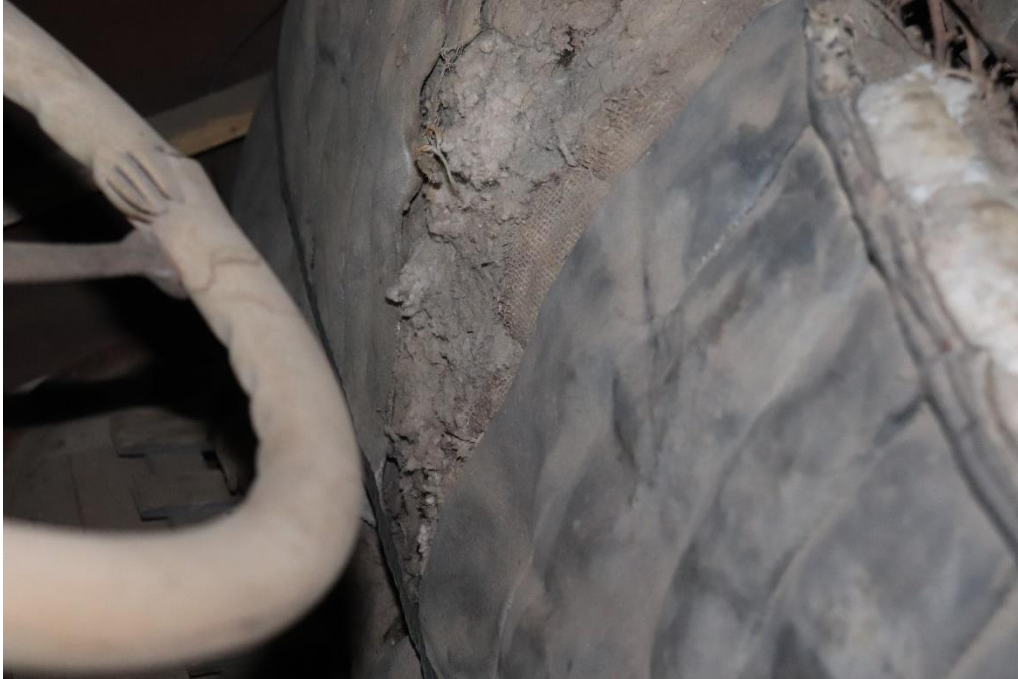
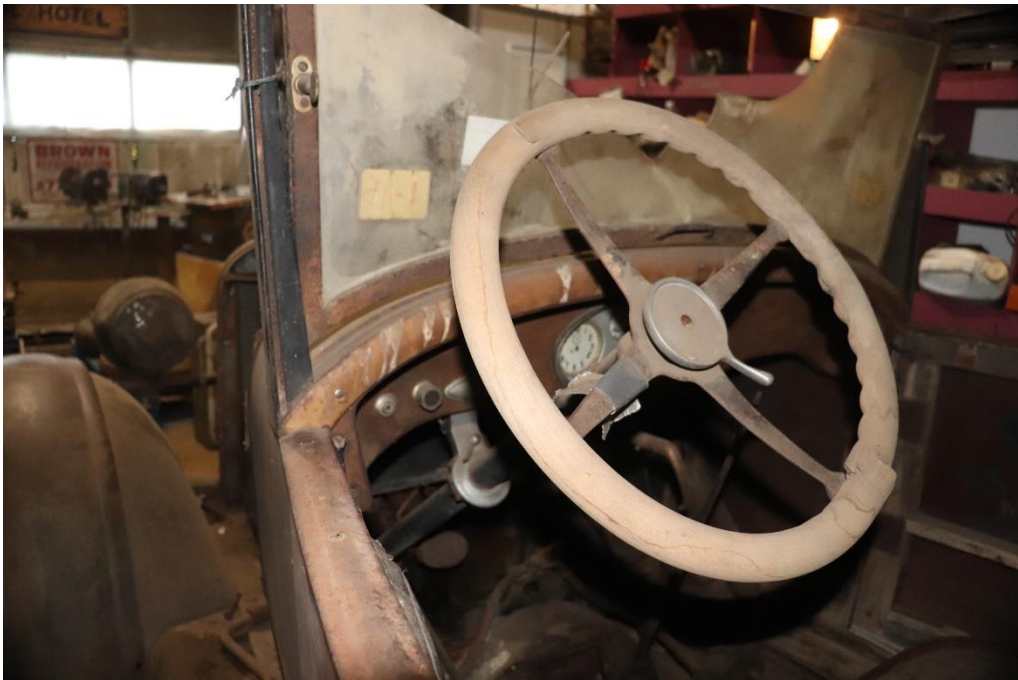
The interior is in poor condition, badly aged and being used for parts storage.

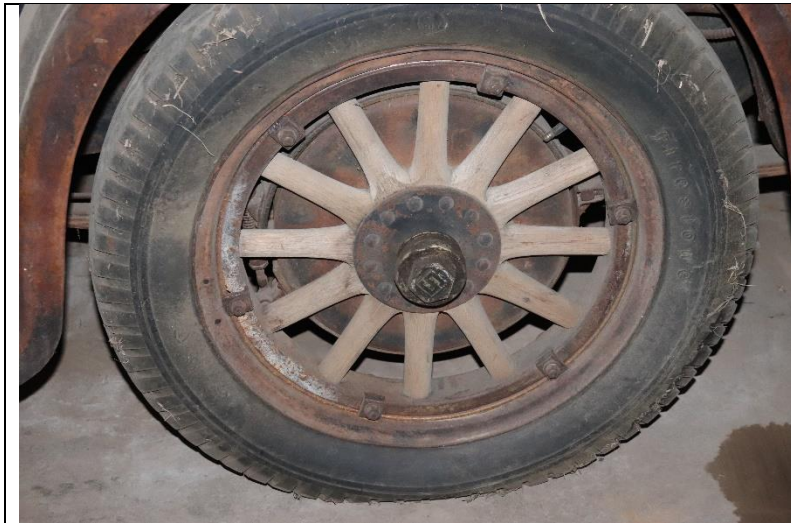
Factory spoked wood wheels are unrestored and in good condition.

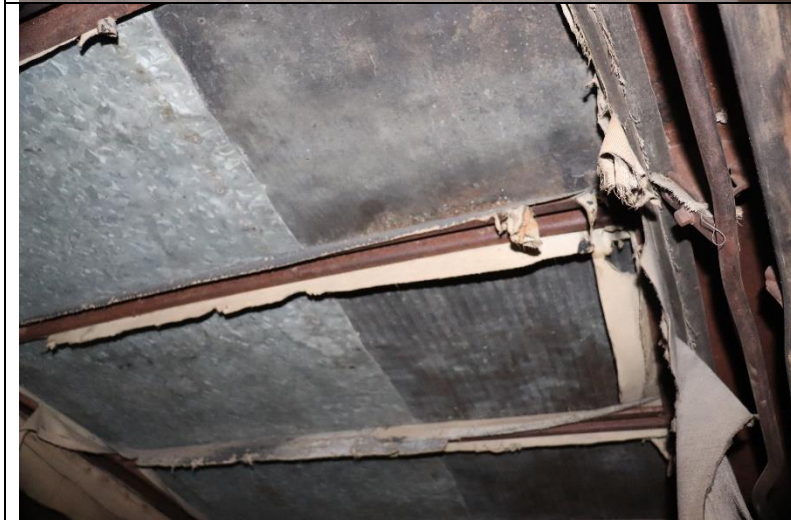
The headliner is in poor condition.

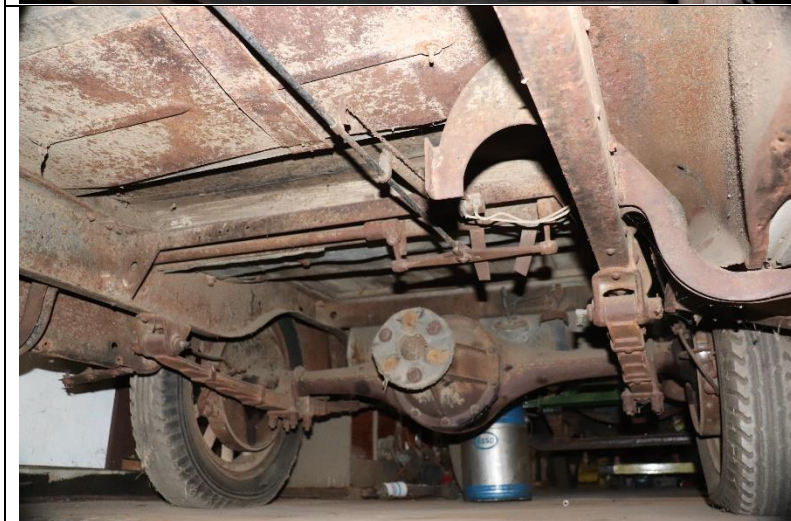
The frame and undercarriage are free of road hazard damage but all underside components show some general surface rust. The exhaust system is not complete with only the factory cast iron exhaust manifold in place.

The undercarriage shows some general light surface rust.
